CO Duett Coulter Assembly

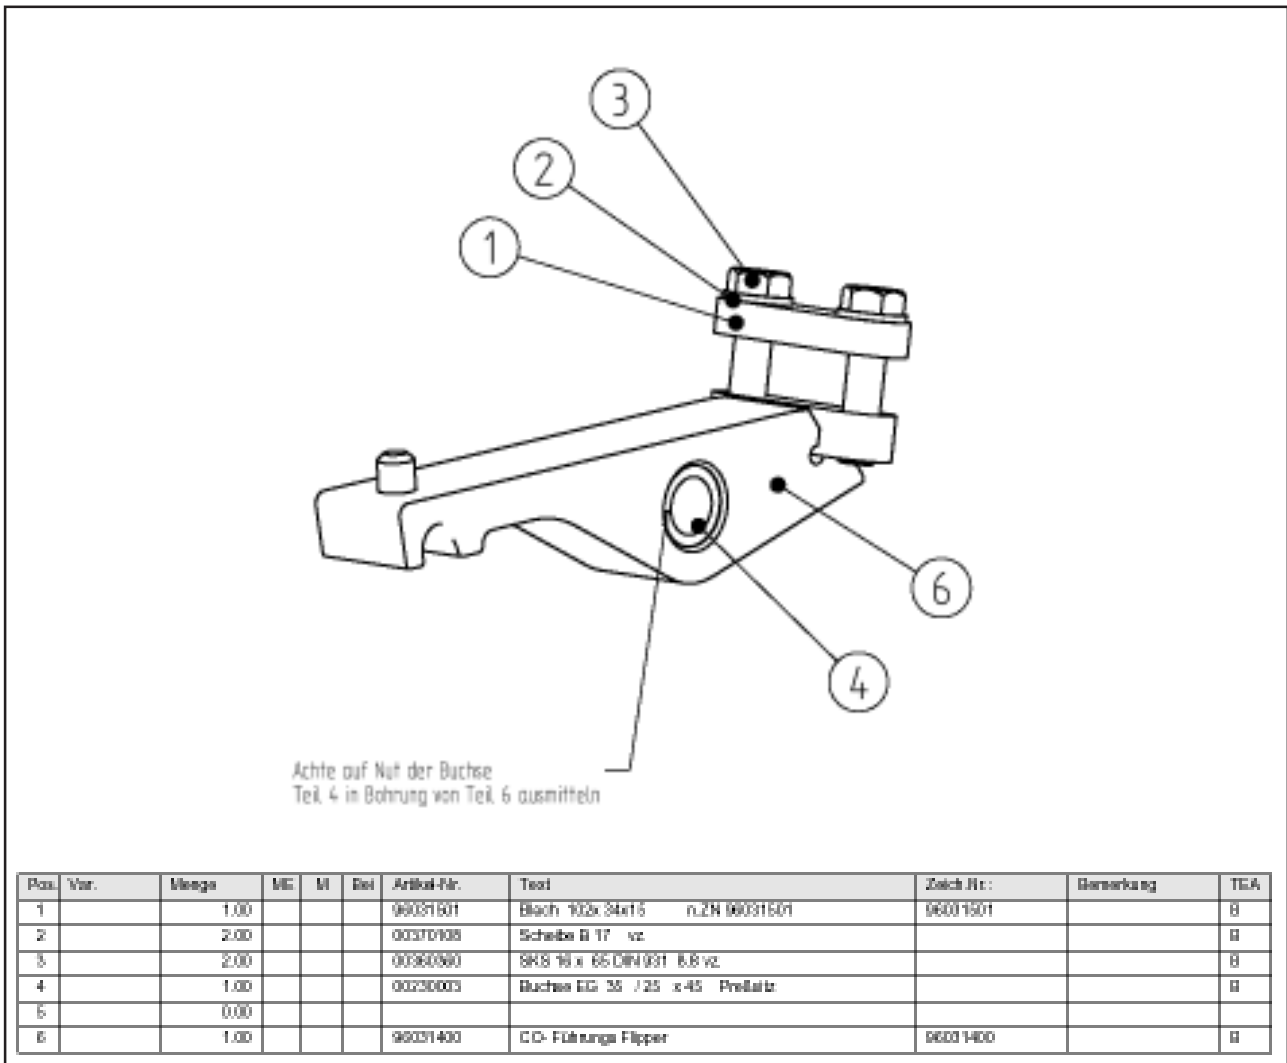
The sign of the wear is excessive movement of the leg in a sideways or upward movement causing the sown bands of seed to merge together or leave big gaps between the bands along with inconsistent sowing depth. This is exaggerated in heavier soil conditions or direct drilling.

The wear occurs between the flipper (item no. 15 - Part no. 33645010) and the cast bottom plate (item no. 7 - Part no. 33645001). To overcome the wear a new design of retrofit flipper has been developed.

- Shank has to move on the pivot pin
- Improved trip force
- No sideways movement. The new flipper now clamps to the leg ensuring that the leg has to use the pivot pin, the old design did not.

The Part no. for the new style 'Flipper' is 96031500. Please note this part is only available as a retrofit part and is not fitted as standard to machines.
