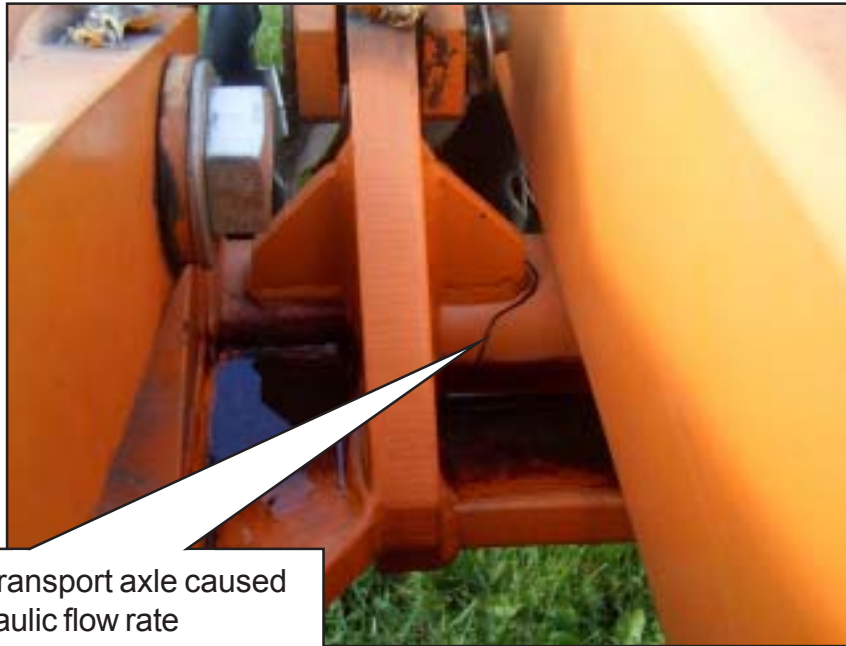
Damage to transport axle caused by high hydraulic flow rate

This can generally be caused by the hydraulic flow rate in tractors being set too high. For all machines, Simba recommend that a low oil flow is used (or low flow selected) in order to avoid damage to the tractor or implement.

As a general rule the tractor oil flow rate should be set in the lowest setting before starting. This can then be increased to allow the desired rate of operation as applicable. This will minimise excessive oil flow and consequent power usage and heat generation.
