Terra-Grip Tine Beam Shims

5.4 Terra-Grip Tine Beams

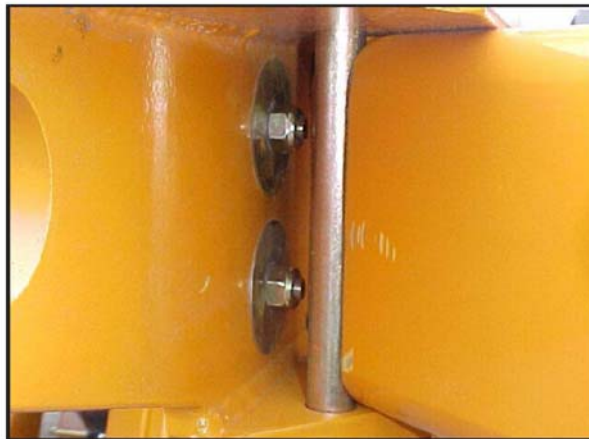
Fig. 5.01: Inner Tine Beam Shims

A pair of shims located within the tine beam on 380 models are there to retain the tightness while the machine is in the work position. These shims create a fulcrum which, when the lock bolt is tightened, locks the the wing securely in position by removing clearances in the pivot. The amount of shims can be varied to give a gap of 2-3mm at the point indicated in *Fig. 5.02* before tightening the lock bolt (which will close the gap).

We are receiving reports of isolated instances where the Terragrip tine beams are not being shimmed in the correct manner as per the instruction in the manual. Failure to adhere to these instructions will result in premature wear and damage of the tine beam pivot. Please find below copy of the instructions which appear in the operators manual. Please ensure your customers are made aware of this adjustment. If extra shims are required please order part number P08440.
